Snagging Report

Apartment 1304

Marina Shores , Dubai Marina, Dubai

01
Dec
2023

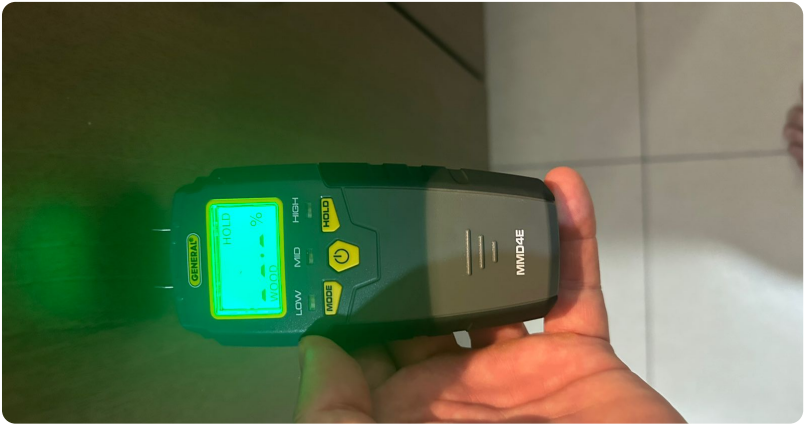
</div> <div>Joinery</div> <div>Door</div> <div>Moisture meter has detected levels of moisture in the joinery main entrance door where there is evidence of a leakage in the ceiling access panel above. Door should be replaced</div>	<div>2</div> <div>Entrance Foyer</div> <div>

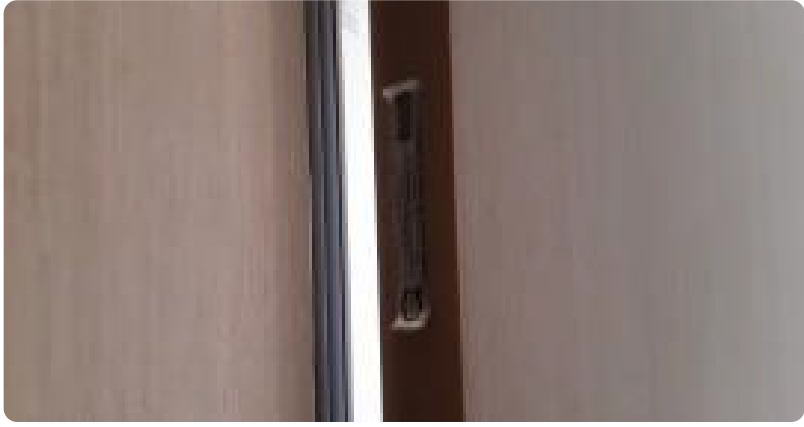
</div> <div>Joinery</div> <div>Door</div> <div>Peeled off fire-rated tag needs to installed correctly or replaced with new.</div>
<div>4</div> <div>Entrance Foyer</div> <div>

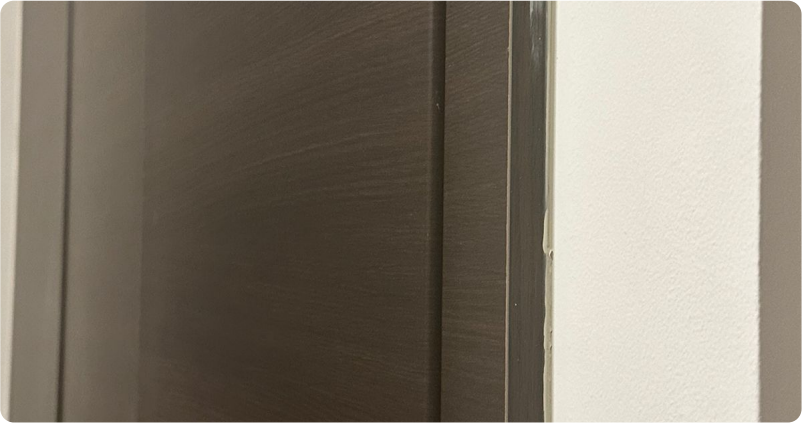
</div> <div>Joinery</div> <div>Door</div> <div>Maintenance storage door has poor finishing at the transition to gypsum wall and also splatters of paint on the doors</div>	<div>5</div> <div>Entrance Foyer</div> <div>

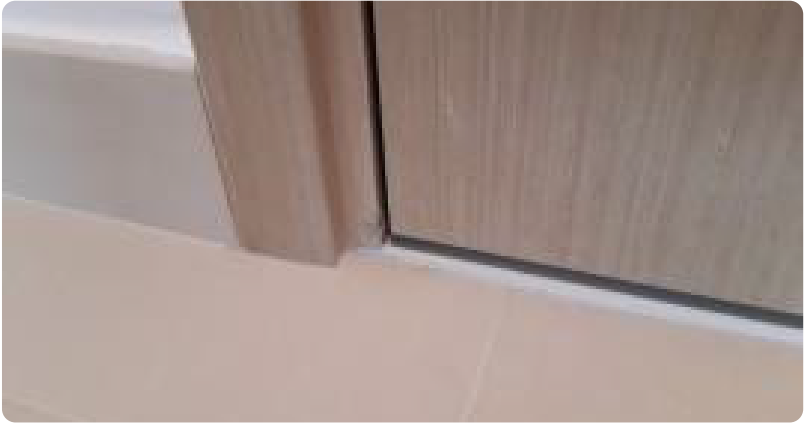
</div> <div>Joinery</div> <div>Door & Frame</div> <div>Chips to door frame which will become more severe if not treated nad repaired correctly</div>	<div>6</div> <div>Entrance Foyer</div> <div>

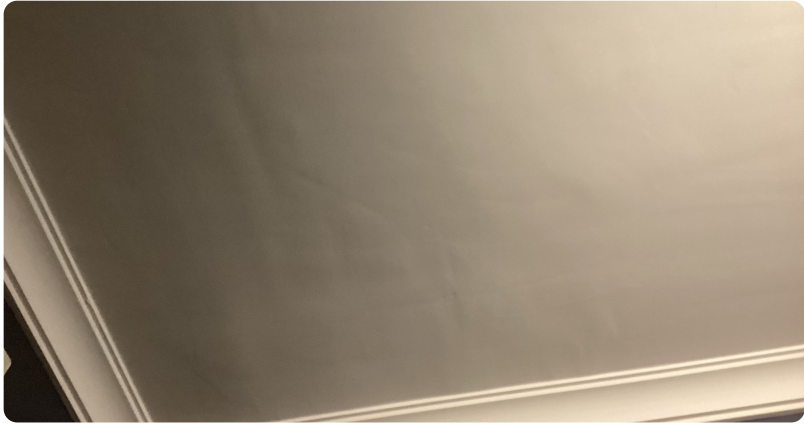
</div> <div>Architectural</div> <div>Ceiling</div> <div>Poor finishing to the ceiling pant works. Would recommend heavy sanding filling and repaint to make satisfactory.</div>

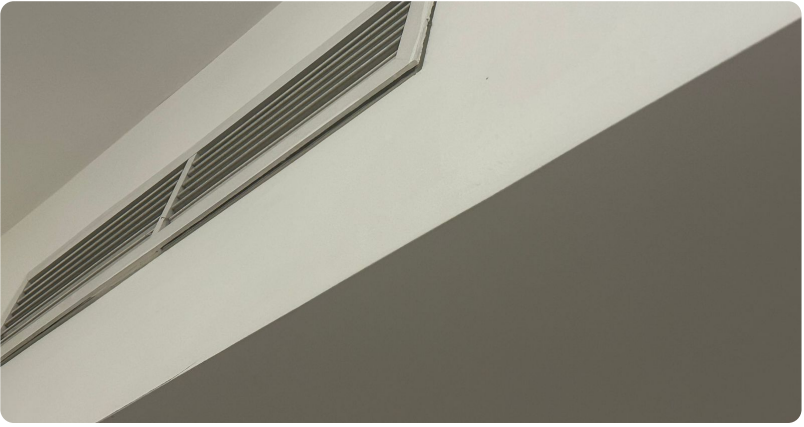
</div> <div>Architectural</div> <div>Walls & Ceiling</div> <div>Air vent grill is not installed correctly. Needs to be fixed and paint works to be repaired after.</div>	<div>8</div> <div>Entrance Foyer</div> <div>

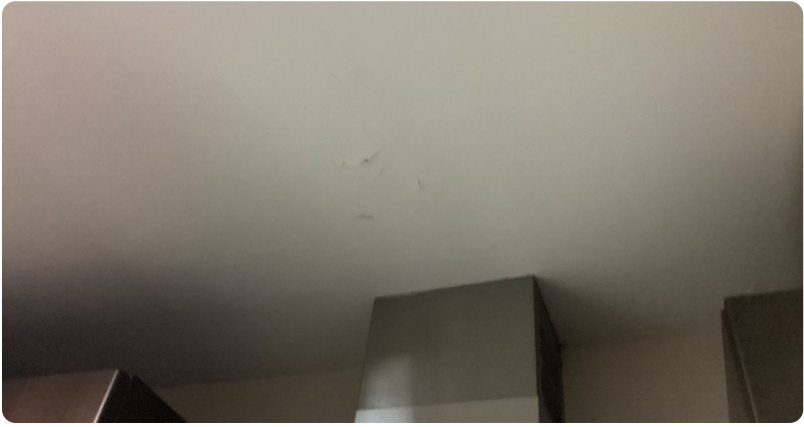
</div> <div>Architectural</div> <div>Skirting</div> <div>Paint is peeling of ceiling next to the extract hood. Sanding filling and repainting is required.</div>	<div>9</div> <div>Entrance Foyer</div> <div>

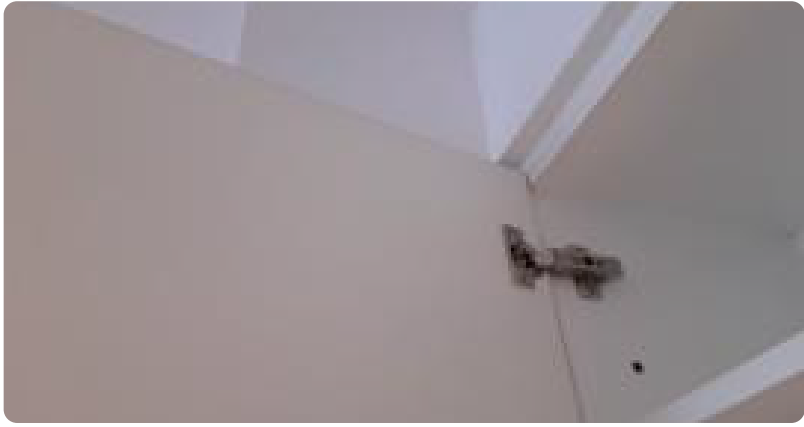
</div> <div>Joinery</div> <div>Cabinet</div> <div>Chips to wall cabinet shutter edges</div>

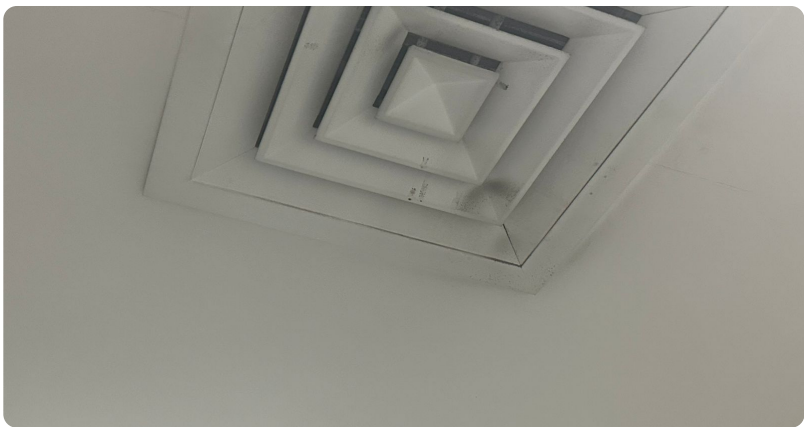
10

Air conditioning vent has black marks nad needs cleaned or replaced.

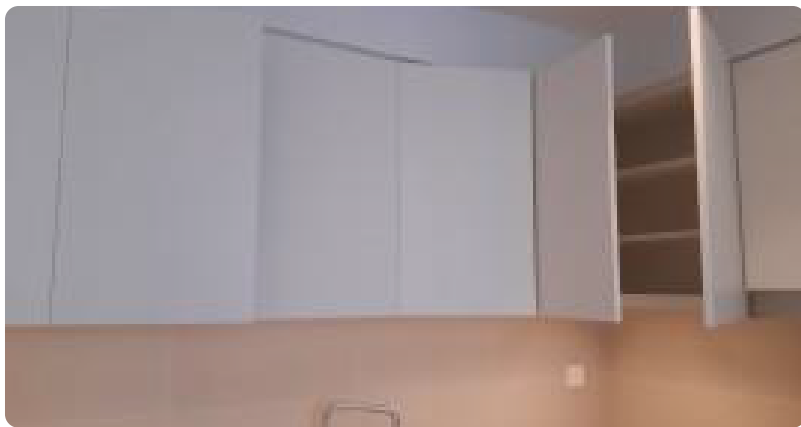
11

All shutter to be adjusted as shutter not closing automatically

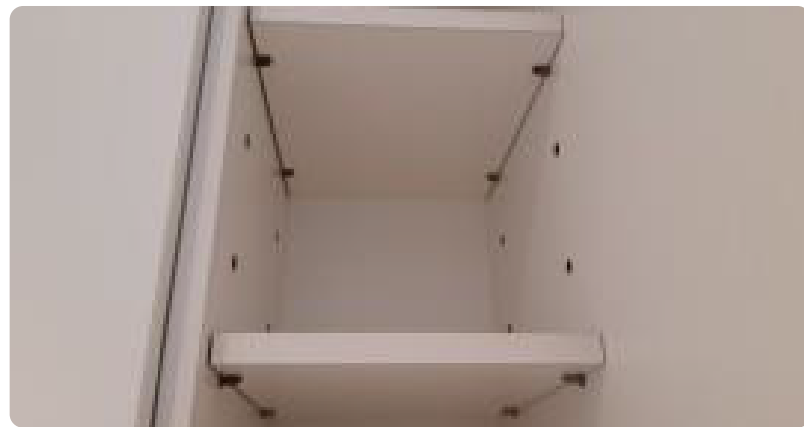
12

Rust to cabinet partition panel support

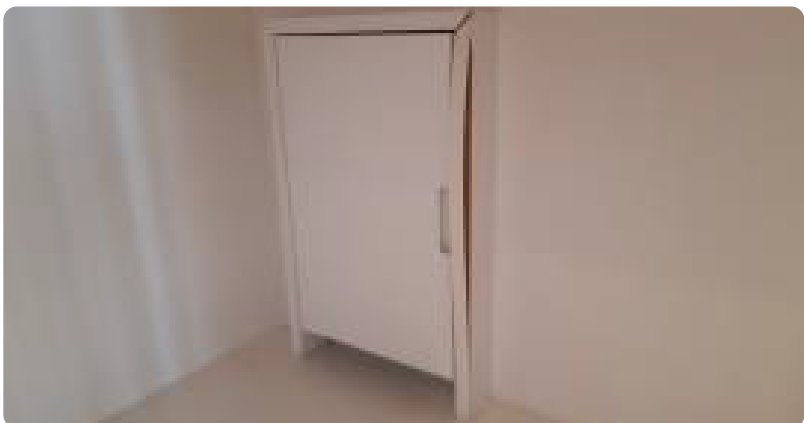
13

Detached lipping to cabinet panels

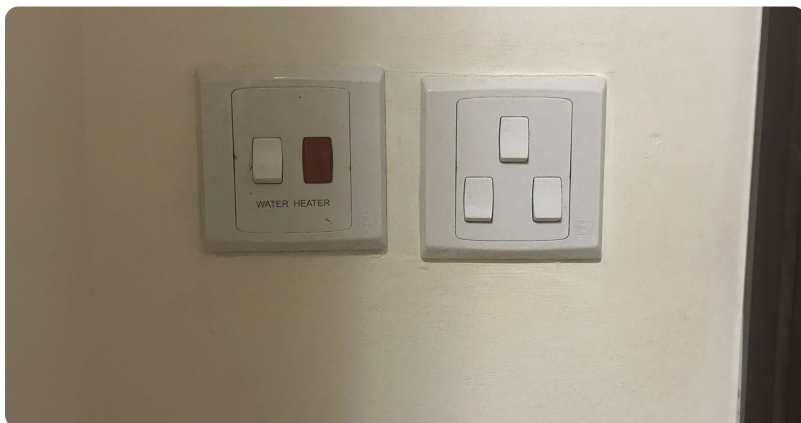
14

Sockets are not level and different heights . Need to levelled

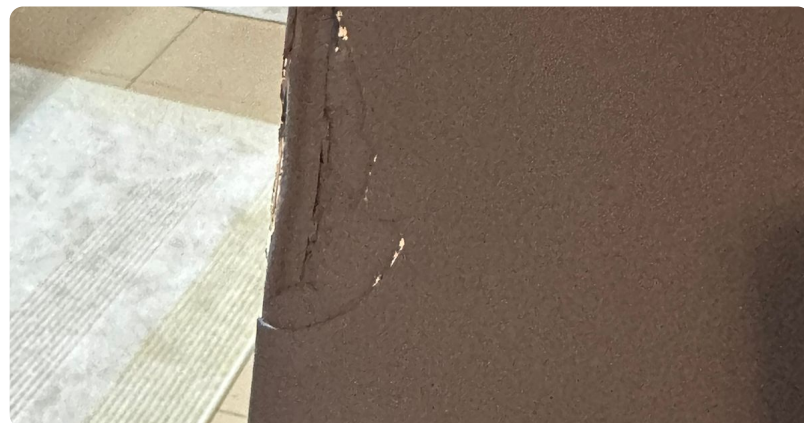
15

Side wall at the entrance to kitchen has a bad damage. Gypsum to be repaired with filling and repaint works

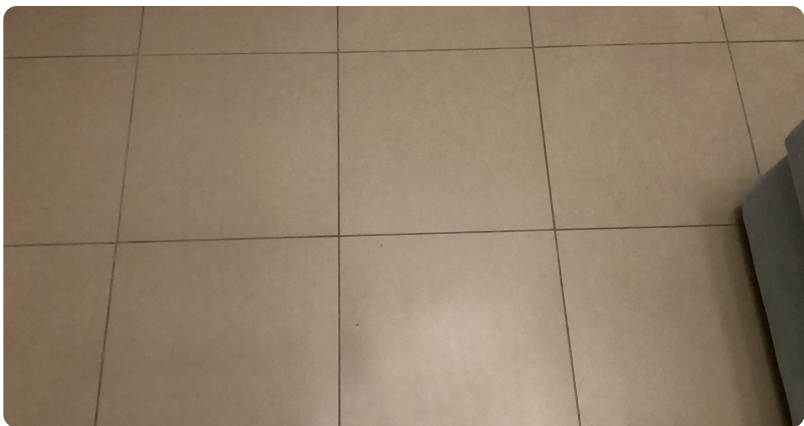
16

Grouting is dirty and needs to be replaced, Minor chips are also noticed on the tiles in front of fridge

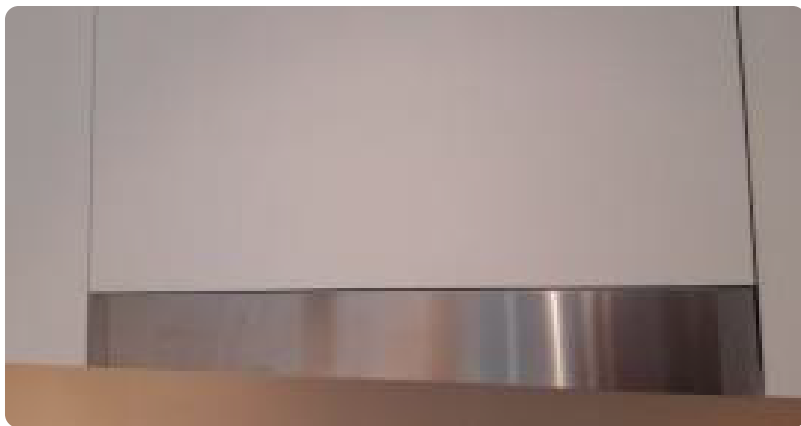
17

Stainless steel handle at hood cabinet has sever scratches and should be replaced.

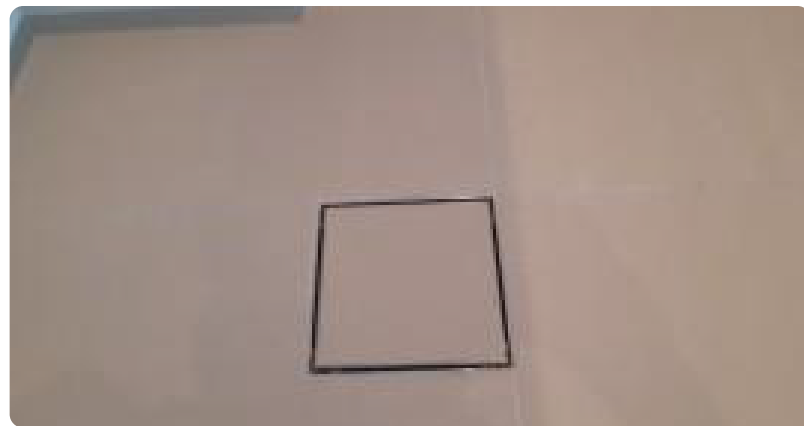
18

Chips to floor tiles around the floor drain.

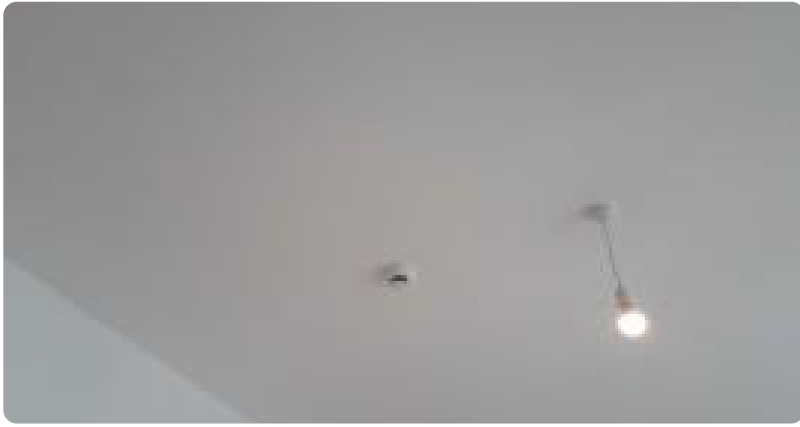
19

Ceiling has cracks around the smoke detector and hanging light.

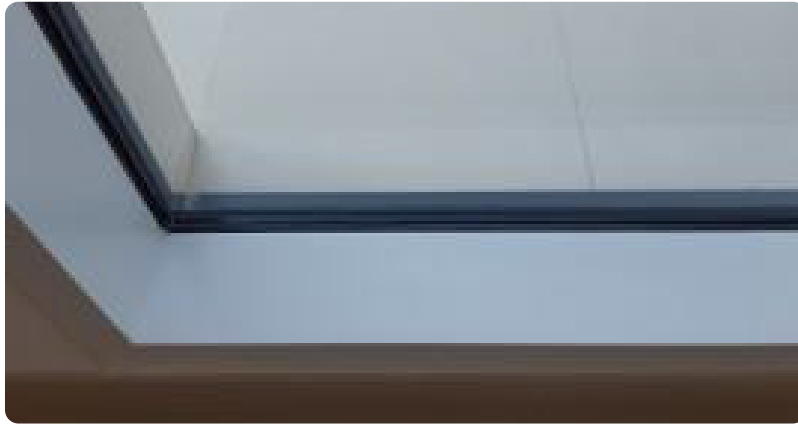
20

Dents to aluminium frame

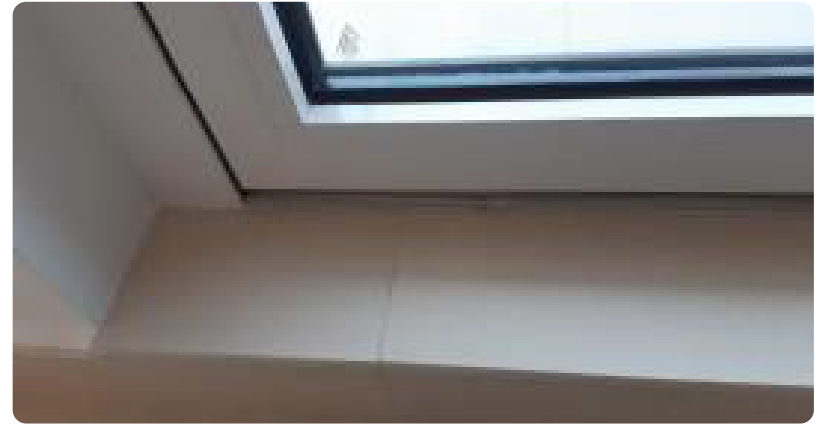
21

Chips to floor below door

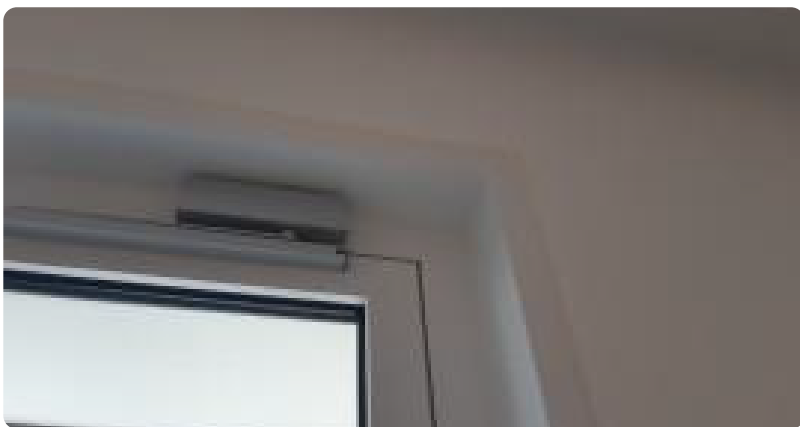
22

Visible gap to door joints

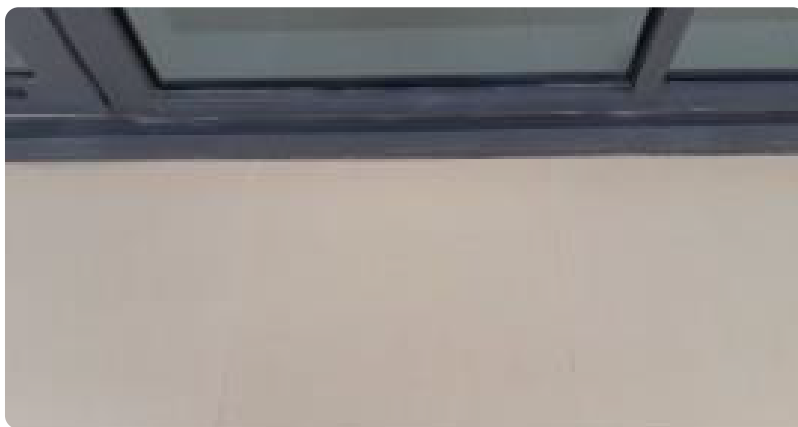
23

Chips to floor tiles

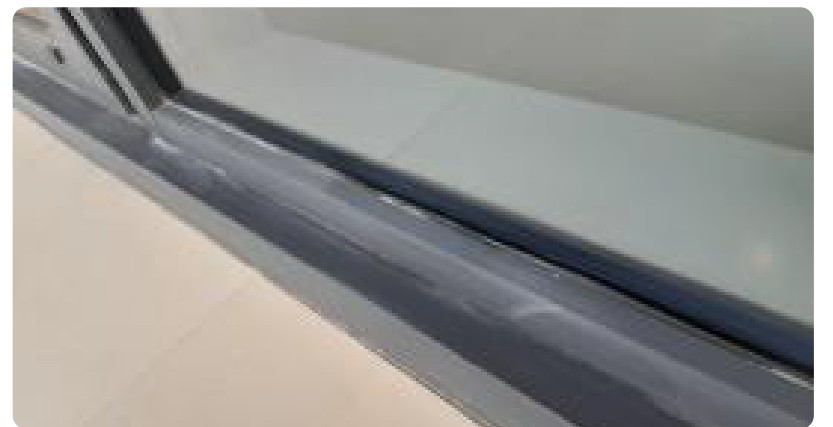
24

Poor sealant application to glass panels

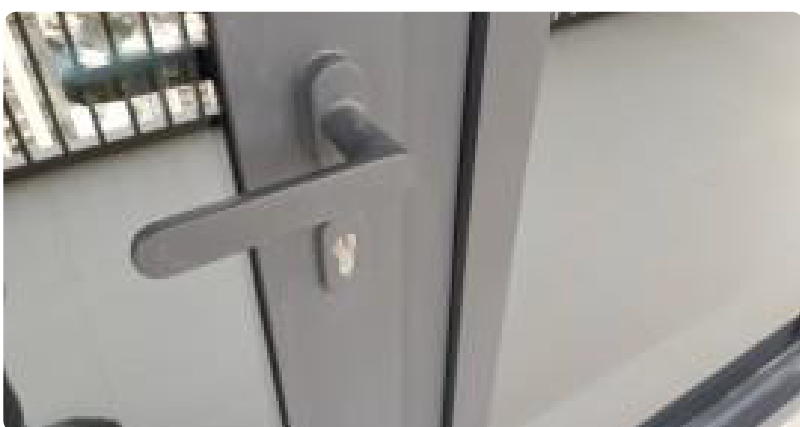
25

Scratches to door

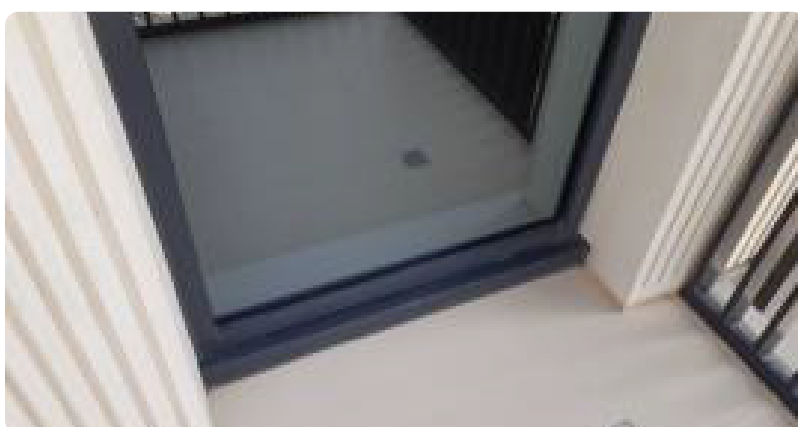
26

Scratches to window frame

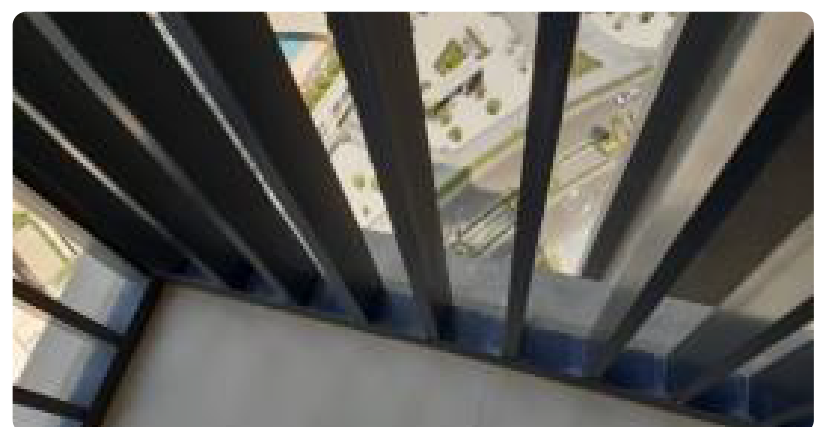
27

Chips to floor edges

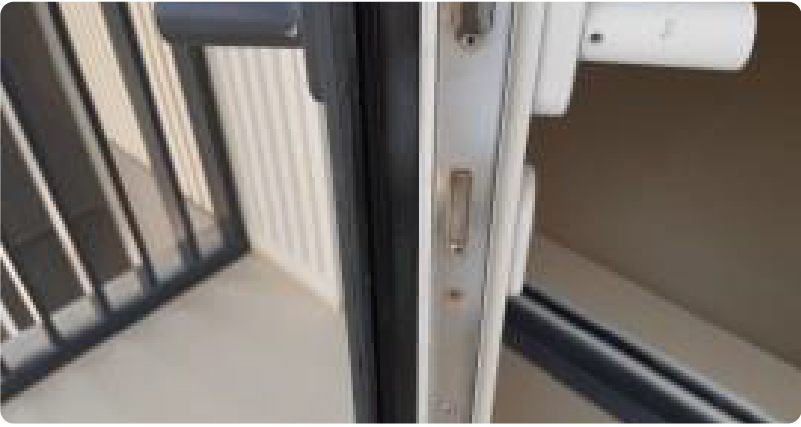
28

Rusted screw to door

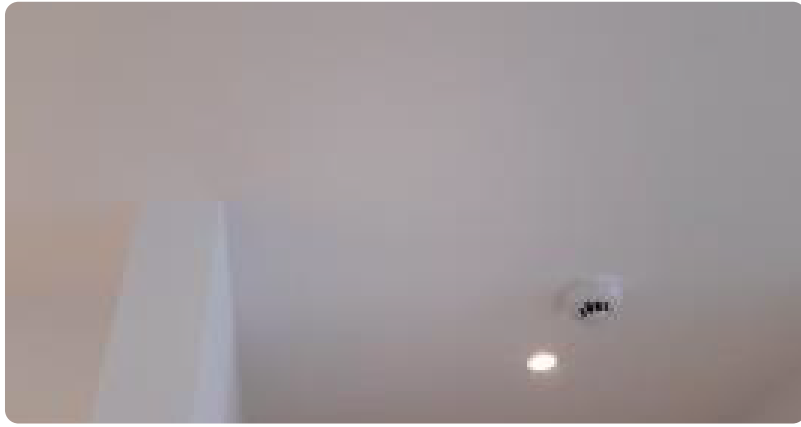
29

Cracks to ceiling

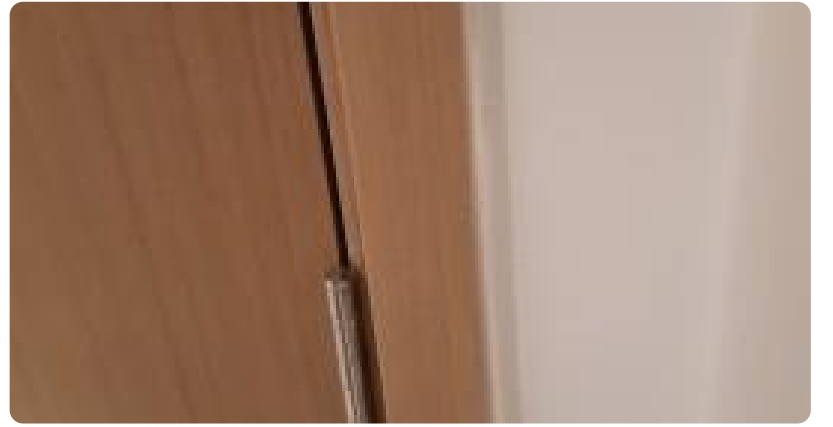
30

Poor sealant around door architrave

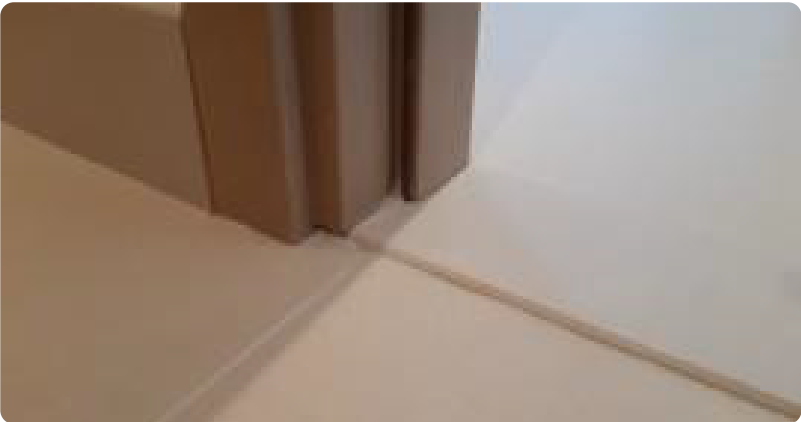
31

Gap below door frame

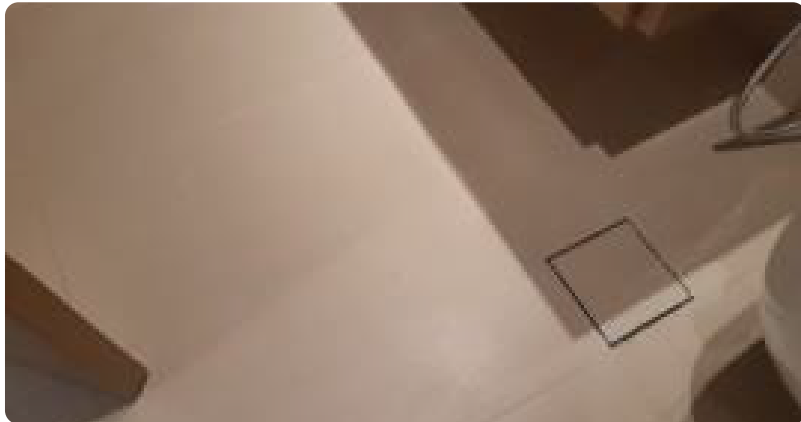
32

Chips to floor tiles

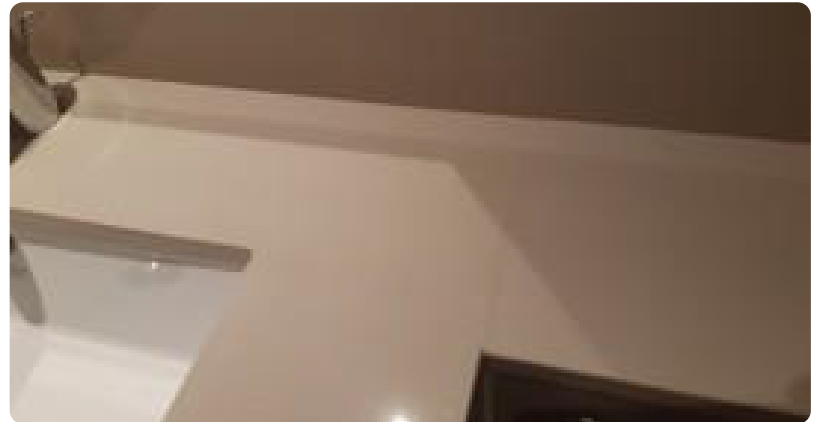
33

Visible repair patches to vanity top

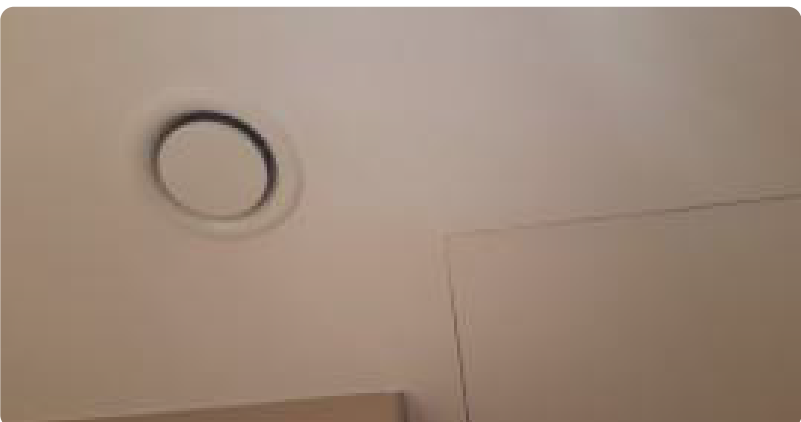
34

Cracks to ceiling

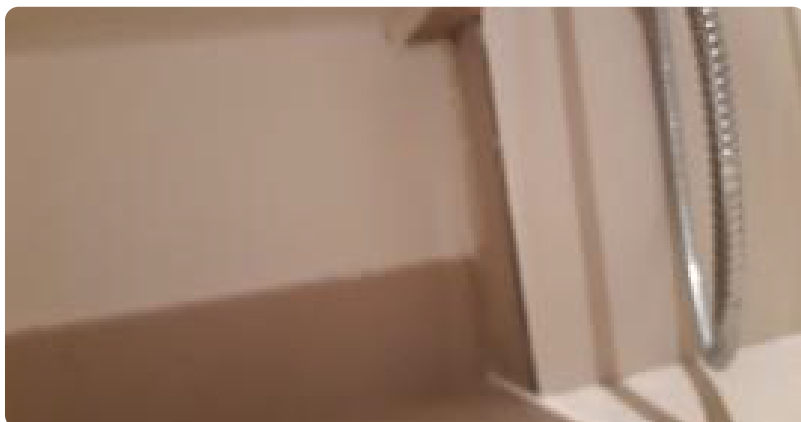
35

Masking tape to be removed and gap to wall joints below cabinet

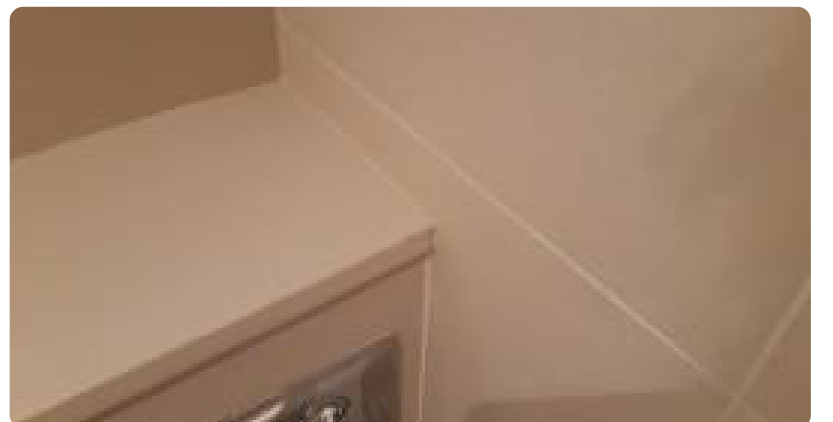
36

Visible repair patches above flush tank

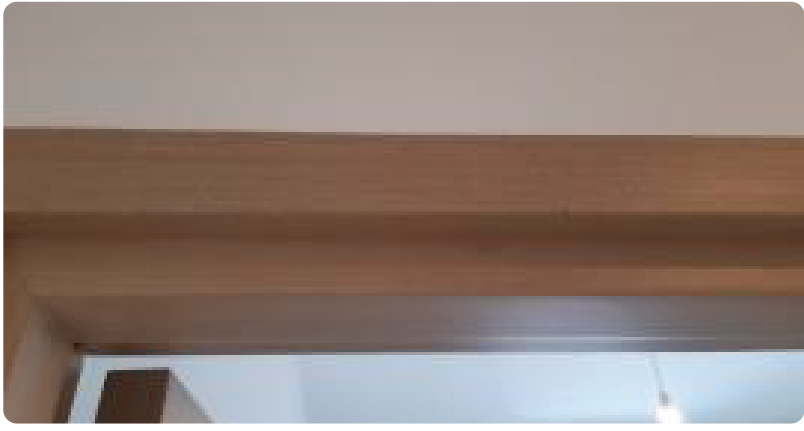
37

Chips to door frame

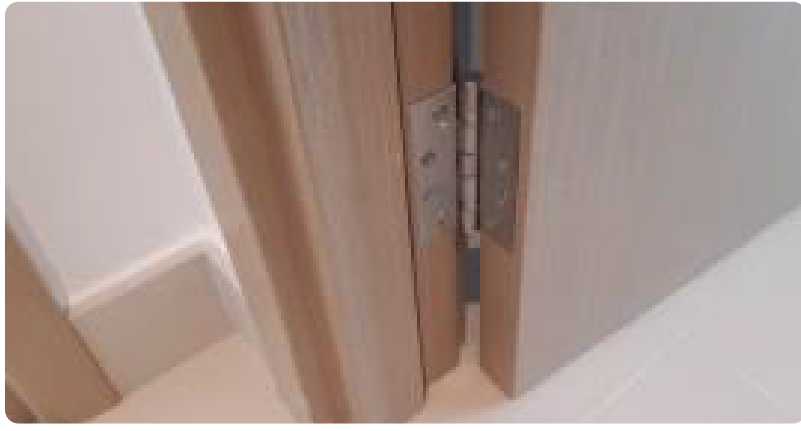
38

Dents to door frame

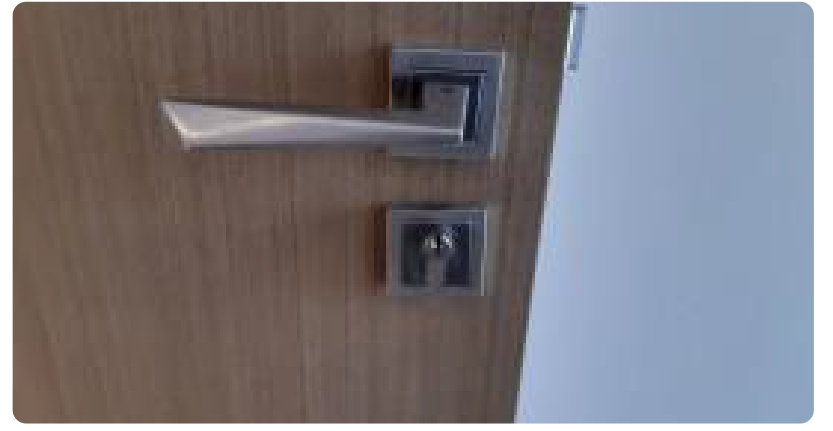
39

Misaligned door handle

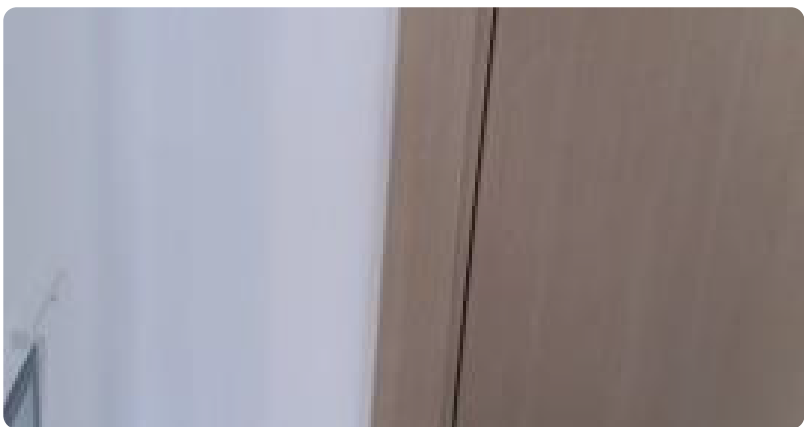
40

Gap around door architrave

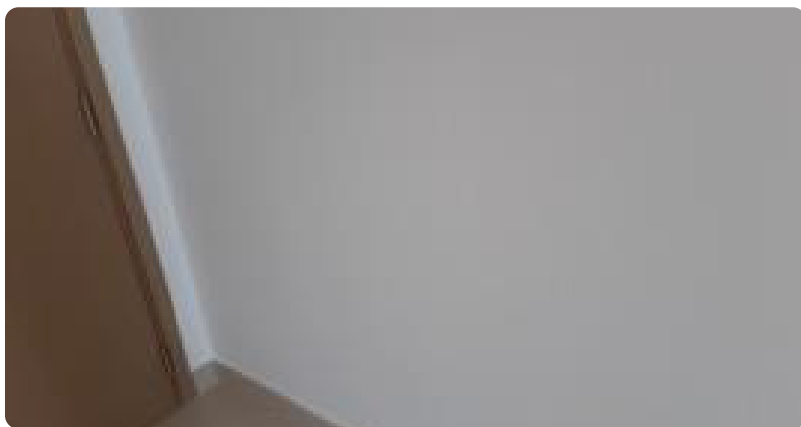
41

Cracks to wall

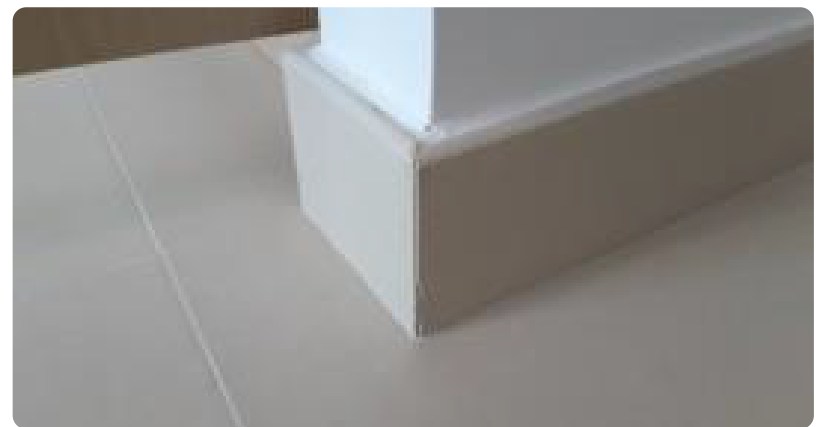
42

Chips and gap to skirting tiles

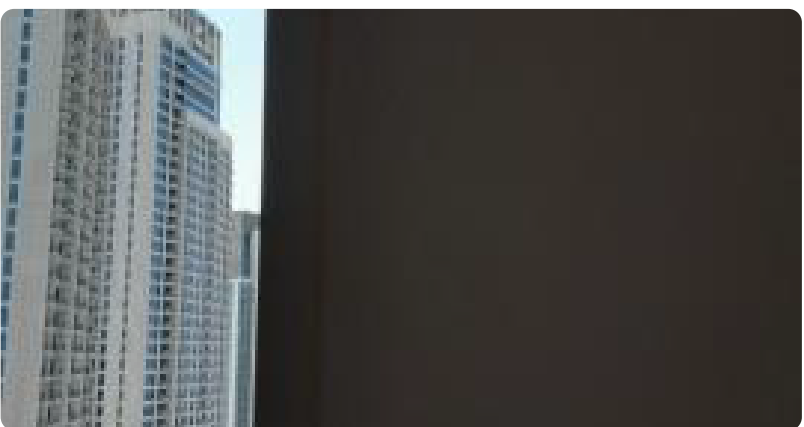
43

Poor sealant application to window frame

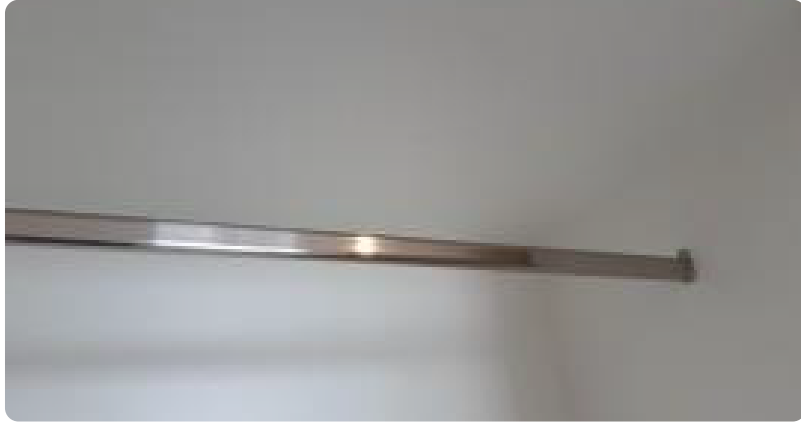
44

Scratches to hanger rod

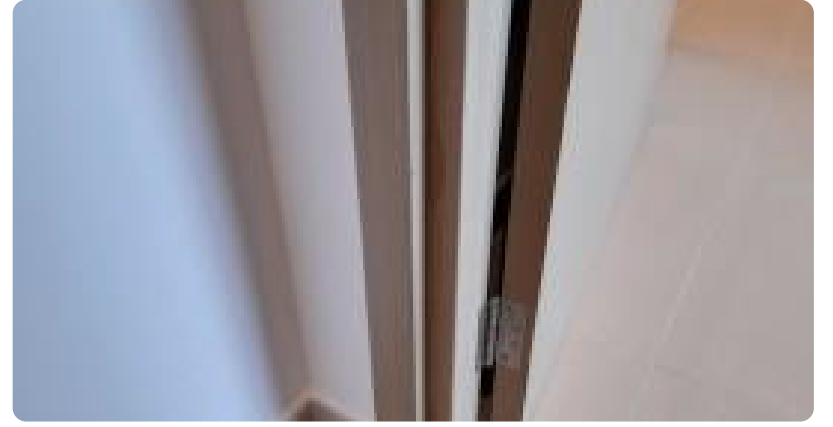
45

Chips to door frame

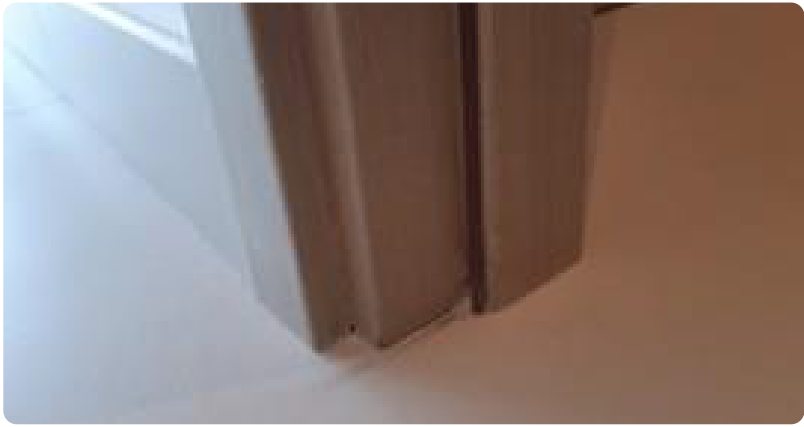
46

Gap below door frame

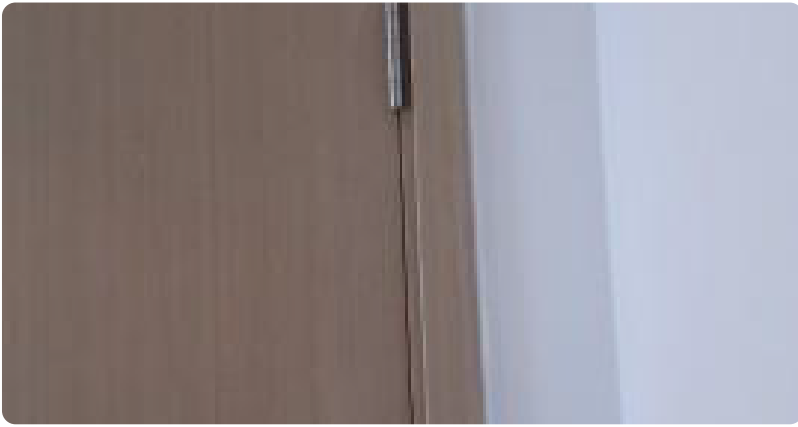
47

Gap around door architrave

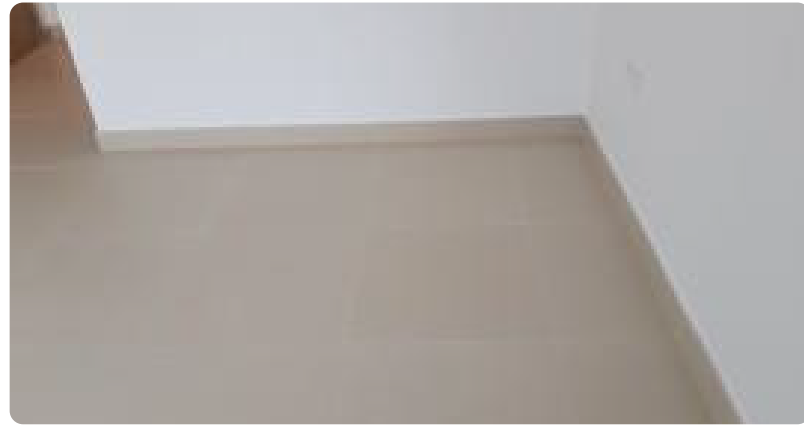
48

Colour variation to floor tiles

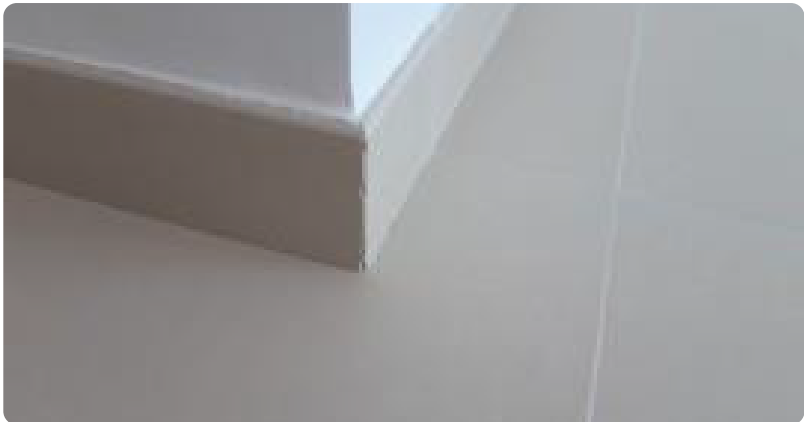
49

Chips and gap to skirting tiles

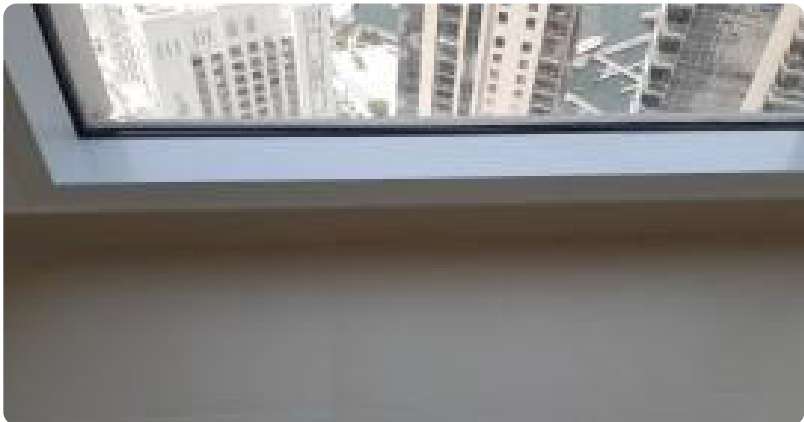
52

Gap below skirting tiles

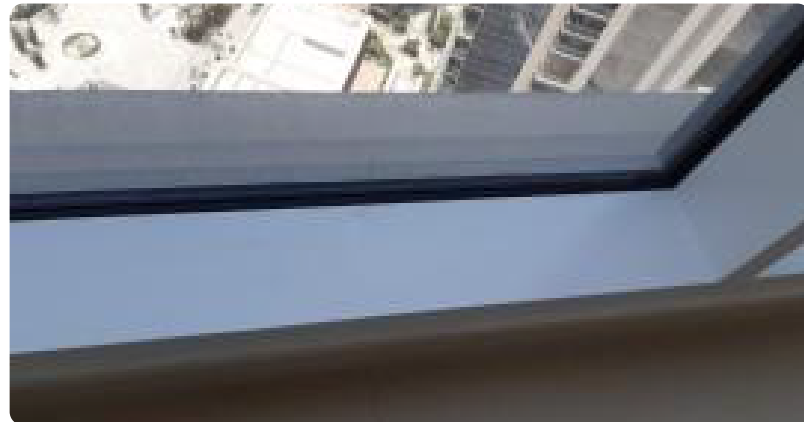
54

Peeled off paint to window frame

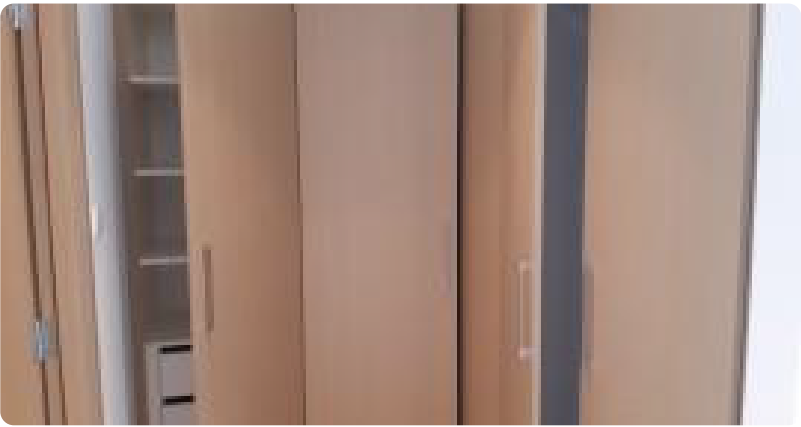
55

Wardrobe shutters to be adjusted as shutter not closing automatically

- No hot water provided during the time of inspection. Water heater should be checked and ensure working capacity.
- All wardrobe and cabinet shutters closing mechanism are to be adjusted as shutters were not closing automatically.

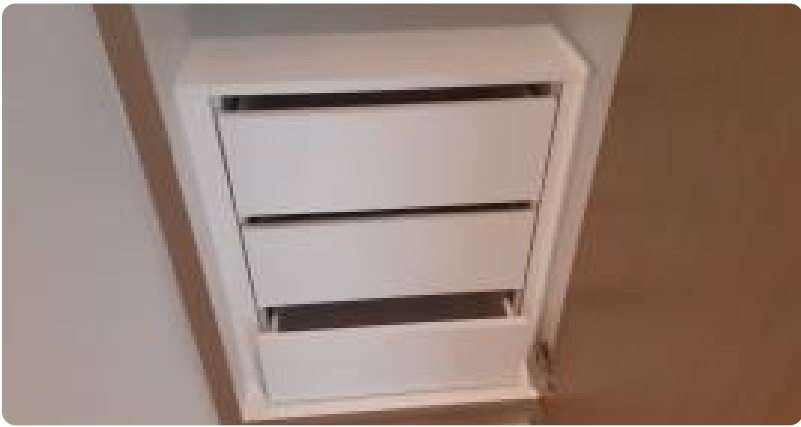
56

Drawer calibration to be adjusted

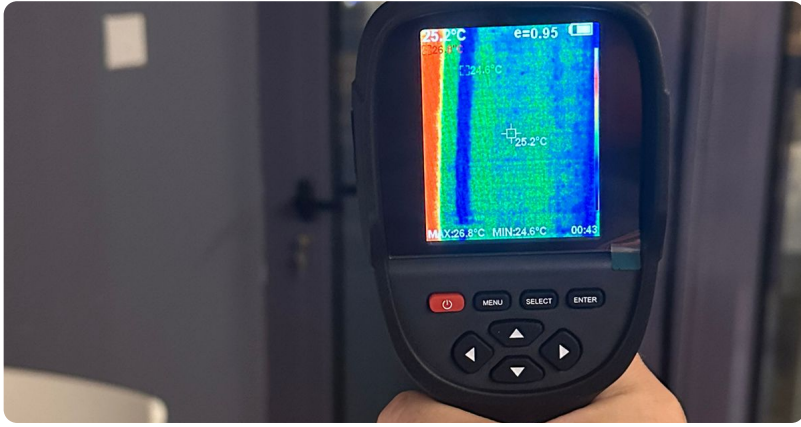
7

Thermal image camera picked up excess heat the door to main balcony. After further investigation leakage of air was detected. Door to be resealed to prevent air leakage

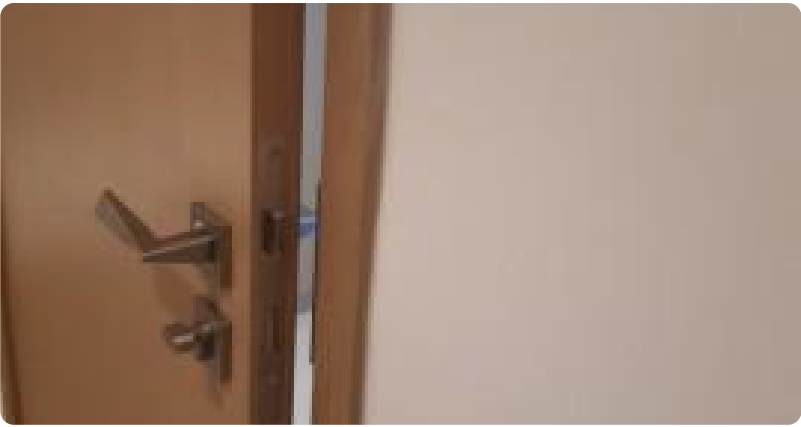
58

Gap around door architrave

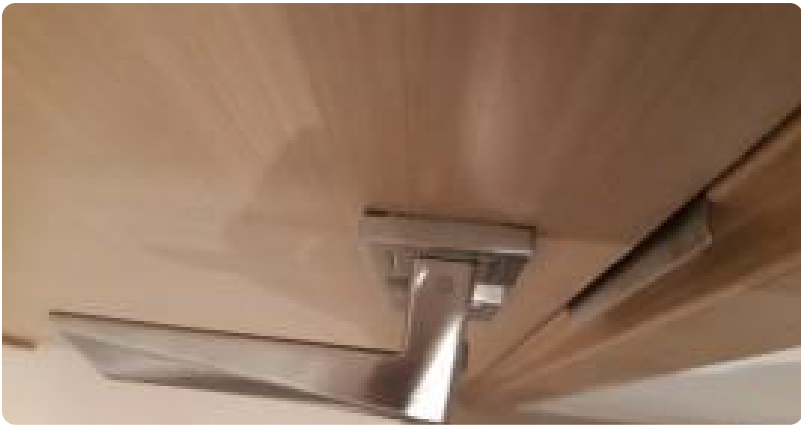
59

Gap around door handle

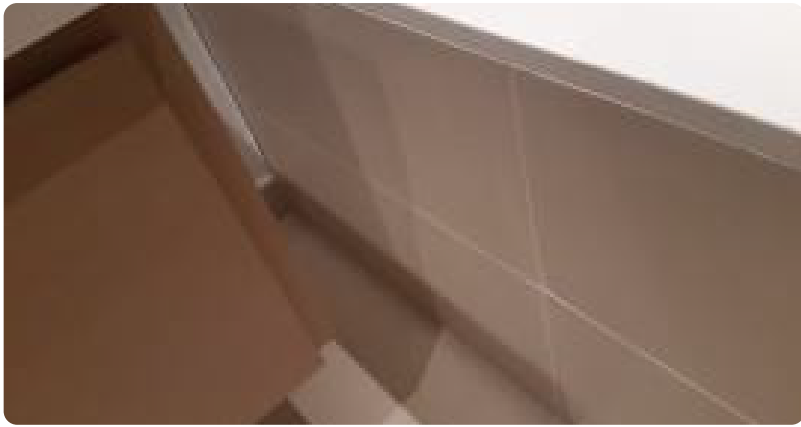
60

Poor grout application to wall tiles

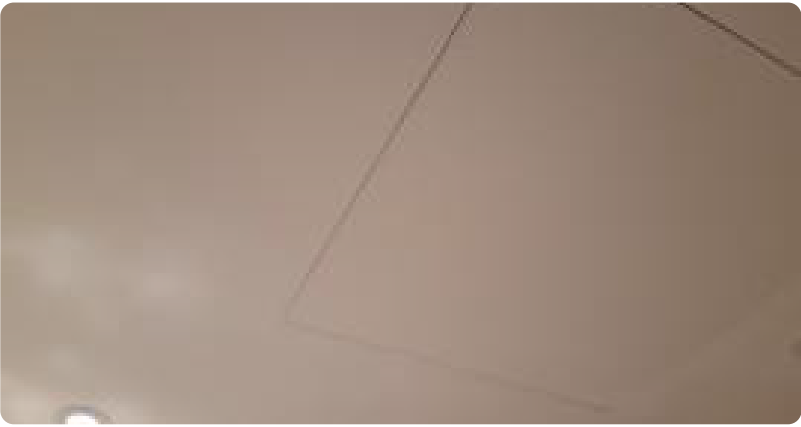
61

Visible patches to ceiling

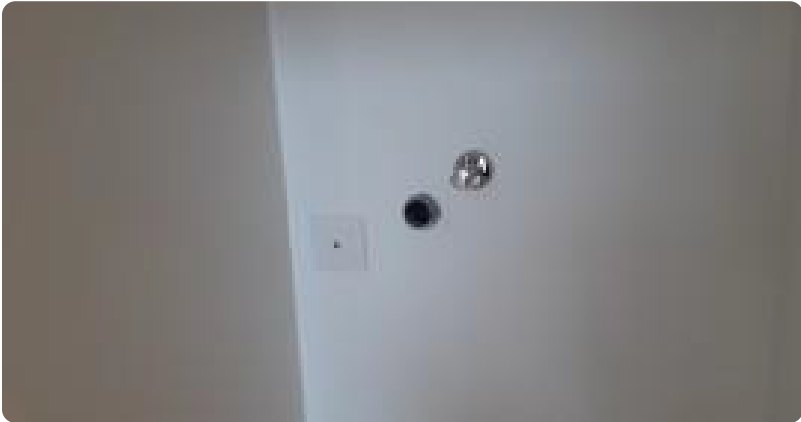
2

Missing cover to drain provision

- Provide cover to drainage provision to prevent debris or unnecessary blockage to pipeline.
- Leakage found in master bathroom below wash basin. Rectify the leakage issues to prevent future damages to cabinet panels.

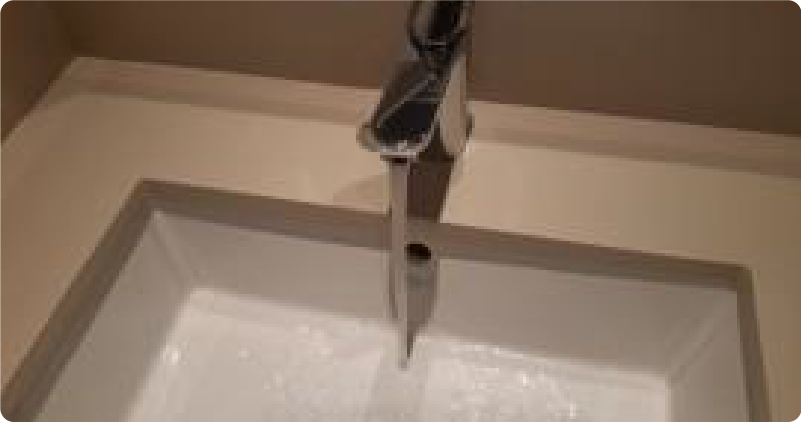
10

No hot water provided within the property

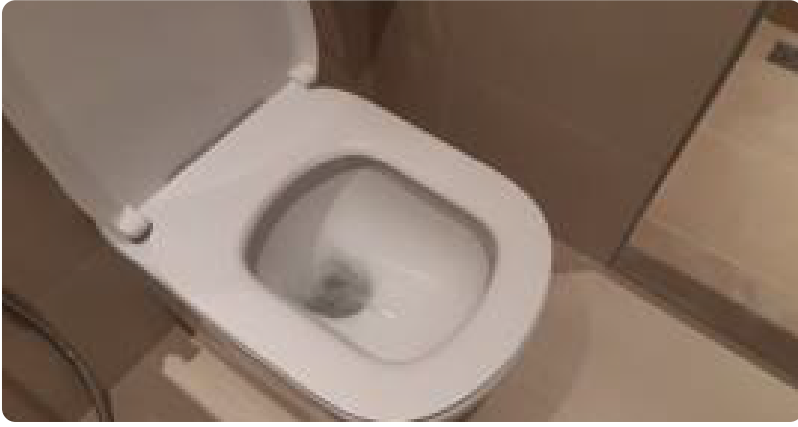
11

Continuous flow of water to water closet

- Continuous flow of water to water closet in powder room was observed at the time of inspection. This should be checked and rectified to reduce unnecessary loss due to water consumption.

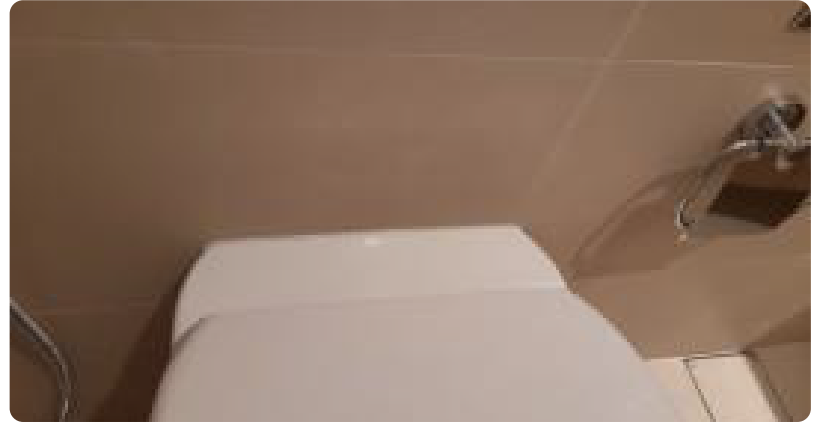
12

Poor sealant application to water closet

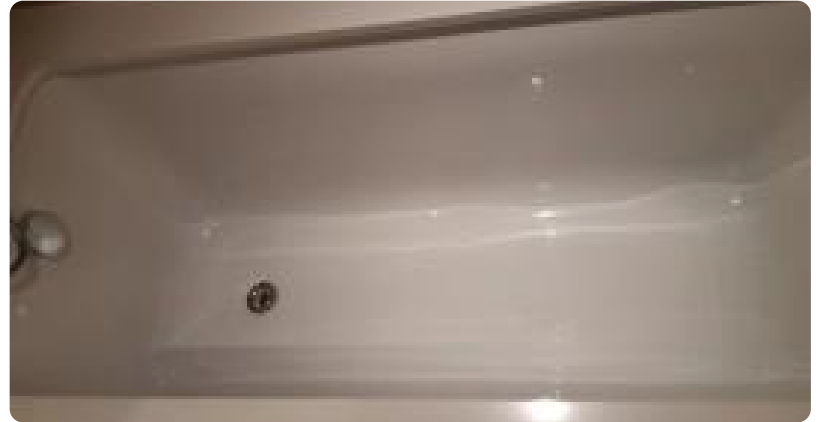
15

Minor scratches to bathtub
