Snagging Report

Apartment 1304

Marina Shores , Dubai Marina, Dubai

01
Dec
2023

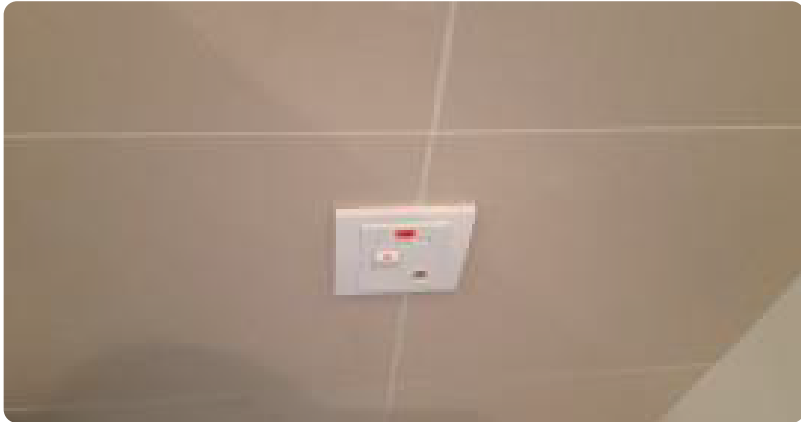
3

Electrical

Power Socket

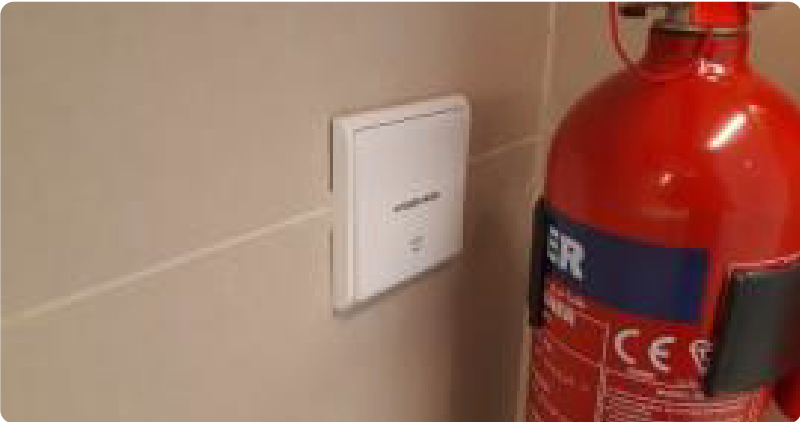
4

Electrical

Switch

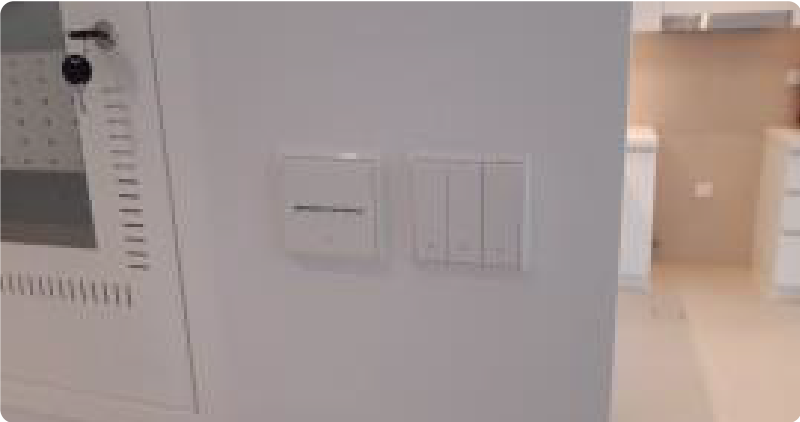
7

Electrical

Switch

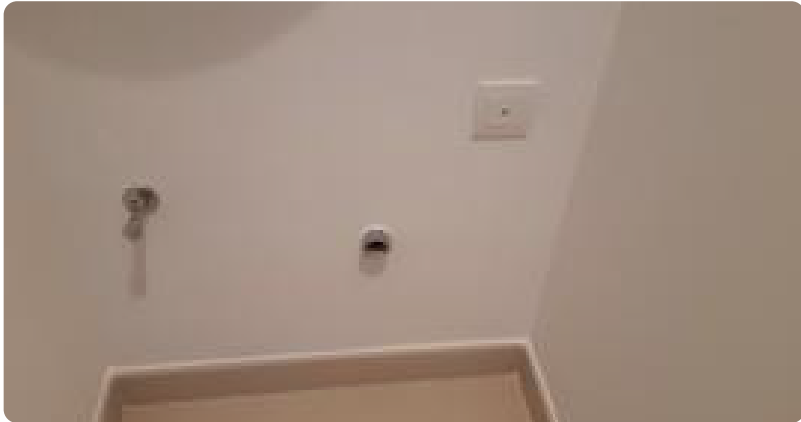
9

Plumbing

Drain Point

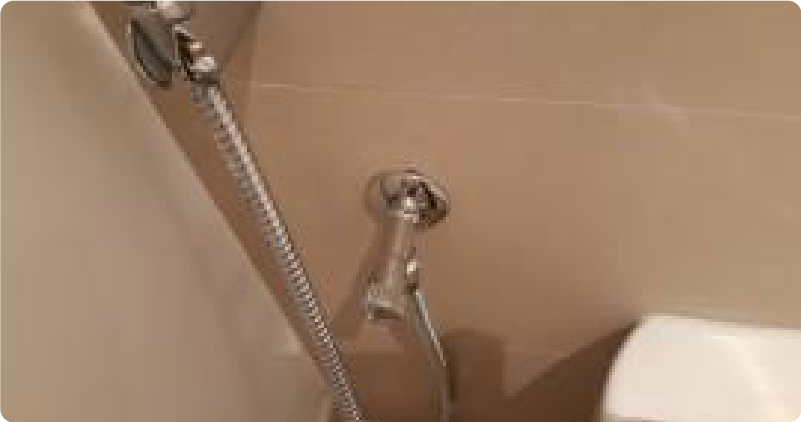
13

Plumbing

Valve

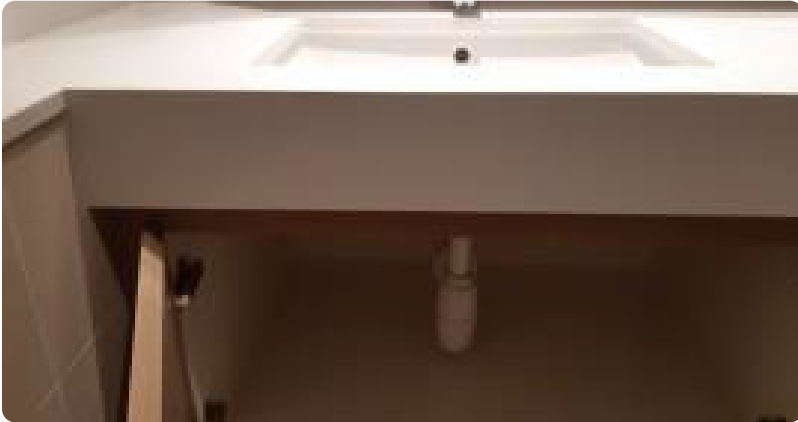
14

Plumbing

Drainage
